IN RE: NEW ENGLAND COMPOUNDING
PHARMACY, INC. PRODUCTS LIABILITY
LITIGATION

AFFIDAVIT OF JEFFREY ERICKSON

PHOTOGRAPHS FROM JULY 9, 2014 SITE INSPECTION

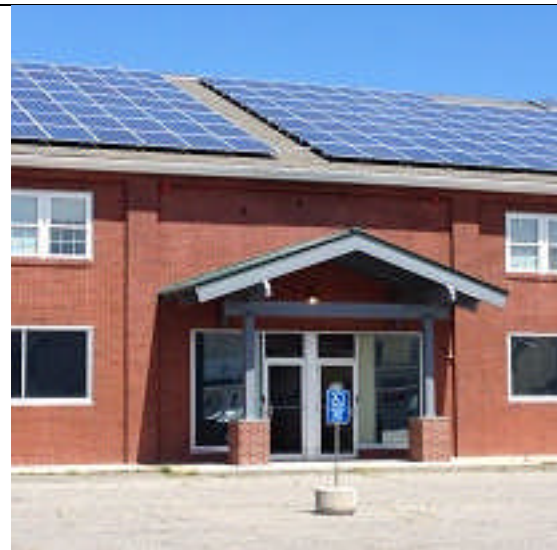
21. When I returned to the Facility on July 9, 2014, I observed that solar panels had been installed on the entire south face of the peaked roof on the south side of the NECC Facility. *See* Figure 1, p. 16. Those panels are not over the 2006 or 2008 Cleanrooms. In fact, the solar panels are over a mezzanine area which is separated in the interior by a wall from both the 2006 and 2008 Cleanrooms. No solar panels were in place at the time the 2008 Cleanroom was completed in mid-2008.

Figure 1 - INSTALLATION OF SOLAR PANELS

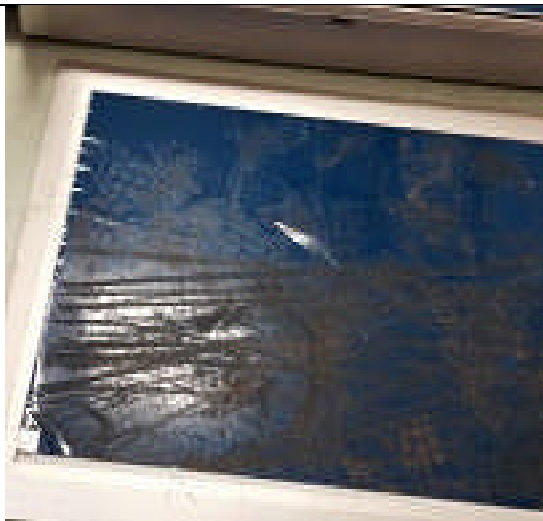
- b. Filthy unchanged “sticky mats” in several areas of the rooms. *See e.g.* Figures 2 and 3, p.16;
 - c. Unsanitary autoclave. *See* Figure 11, p. 17;

Figure 2 - FILTHY STICKY MATS

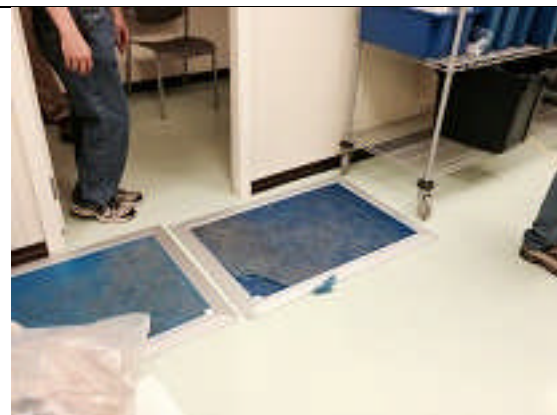
Figure 3 - FILTHY STICKY MATS

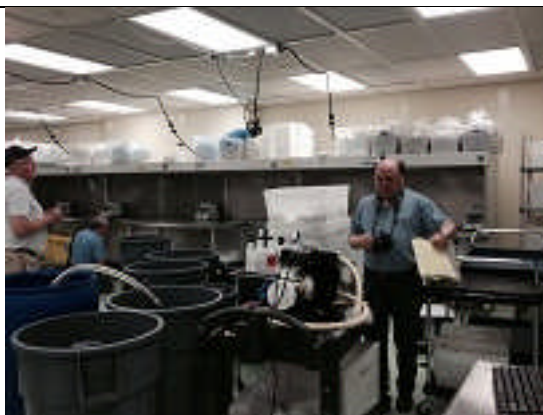
- All of the rooms have cameras, installed by NECC and/or Ameridose or its contractors, mounted on the walls, near the ceiling, with exposed wiring penetrating ceiling tiles without any visible caulking on the cleanroom side, giving the opportunity for foreign matter and contaminants to travel into the cleanrooms;

- d. Not properly sealing penetrations into the room, such as plumbing, cameras, electrical, *etc.*, results in an inability to maintain room pressures;
- e. If water is allowed to penetrate into the room from any source, the risk of growing mold or bacteria is greatly increased. Water penetration was obvious in several areas of the cleanrooms; and
- f. The filth and squalor prevalent within all the rooms demonstrated a complete disregard, or lack of understanding, as to how a cleanroom should be maintained.

Figure 4 - CEILING PENETRATIONS

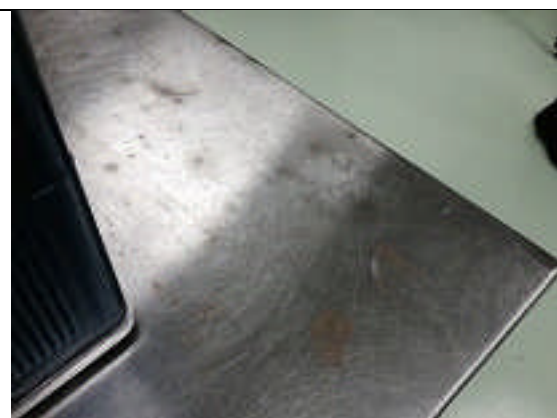
- f. Rust on several doors, walls, processing equipment. *See e.g.* Figure 5, p.16;

Figure 5 - RUST ON PROCESSING EQUIPMENT

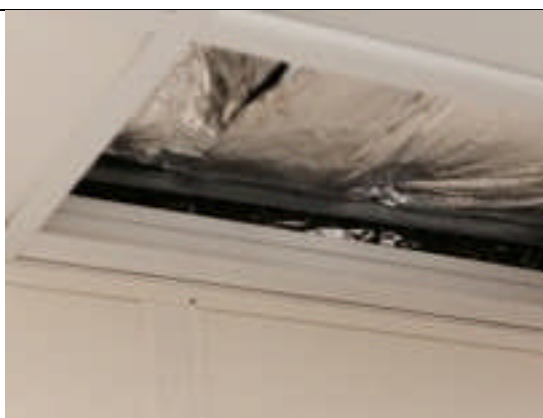
- Some ceiling tiles showed water damage and some ceiling tiles were missing. *See e.g.* Figure 6, p. 16 and Figure 12, p. 17;
- Exposed ductwork had visible water damage to the fiberglass insulation;

Figure 6 - MISSING CEILING TILE

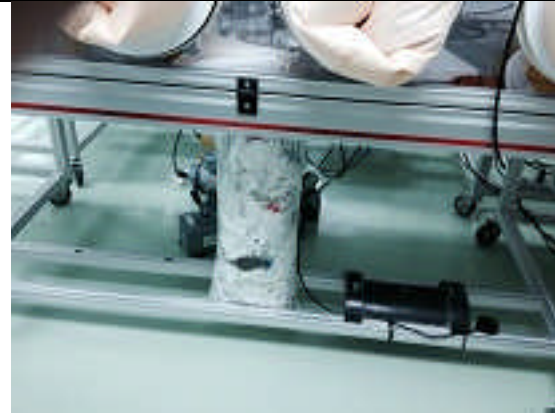
- d. Holes in the main roof that allowed light to show through. *See e.g.* Figure 16, p. 18;
 - e. Full and overflowing garbage receptacles in and around the cleanroom as well as several of the production units. *See e.g.* Figure 7, p.17 and Figure 15, p.18;

Figure 7 - FULL GARBAGE BAG AT PROCESSING EQUIPMENT

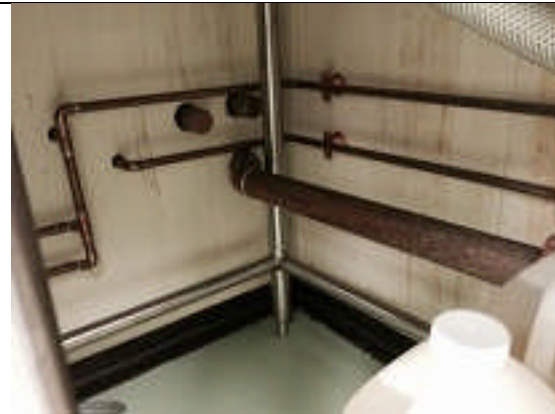
- There are low wall air return grilles in the walls of both of the cleanrooms. Of these, some were so blocked that they were almost impossible to see, many were totally blocked and all were, at least, partially blocked. *See e.g.* Figure 8, p.17;
- All but two (2) of the door sweeps that were installed by Liberty had been removed as evidenced by the visible holes exposed in all doors where they had been attached. *See e.g.* Figure 14, p. 18. There were gaps of 5/8" to 3/4" between the floor and the bottoms of the doors;
- Five of the six door sweeps were removed on the cart Pass-Thru units. There were gaps of 5/8" to 3/4" between the floor and the bottoms of the doors;
- All plumbing pipe installations made by NECC and/or Ameridose or its contractors that penetrated the walls were not sealed and had no escutcheon plates. *See e.g.* Figure 9, p. 17;

Figure 9 - IMPROPER PIPING, RUST

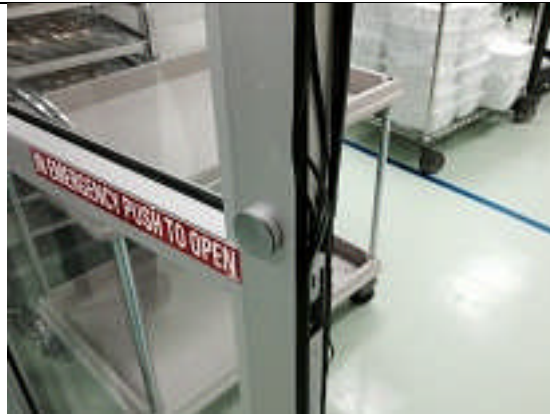
- The Stanley sliding door leading into the Preparation Room for the 2006 Cleanroom was not working. It had damaged and missing gaskets. *See e.g.* Figure 10, p. 17;
- The Cozzuli filling machine, presumably used to fill vials with compounded preparations, was located in the ISO 7 Preparation Room, and less than ten feet from the inoperative Stanley sliding door, which would have allowed for contamination to migrate into the Preparation Room. It is my understanding that filling machines are normally operated in a room with a lower ISO class, *i.e.* a cleaner environment. In addition, the filling machine was located directly below damaged ceiling tiles;
- There were damaged gaskets on all Liberty built and installed Pass-Thru units that were installed in 2006 and 2008. The only undamaged gasket was on a Pass-Thru unit that was labeled “Do Not Use;”

Figure 10 - INOPERABLE STANLEY DOOR, DAMAGED GASKETING

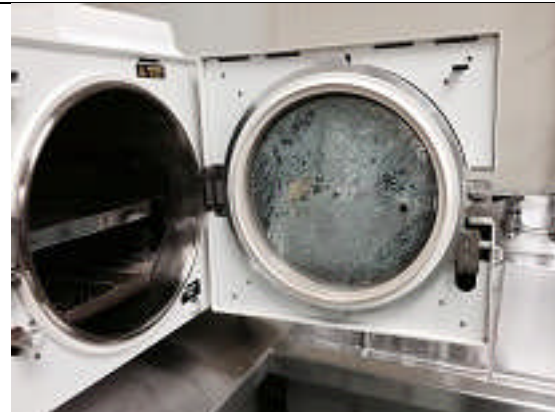
Figure 11 - FILTHY AUTOCLAVE

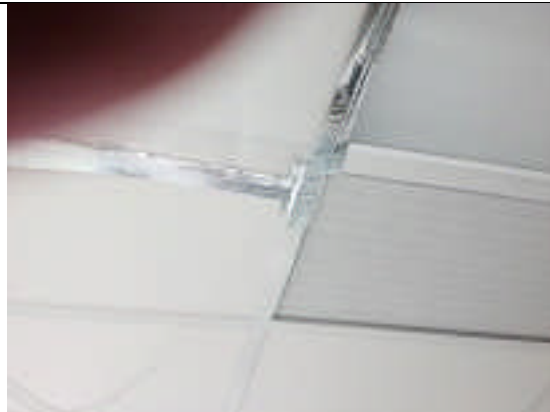
Figure 12 - CEILING TILE

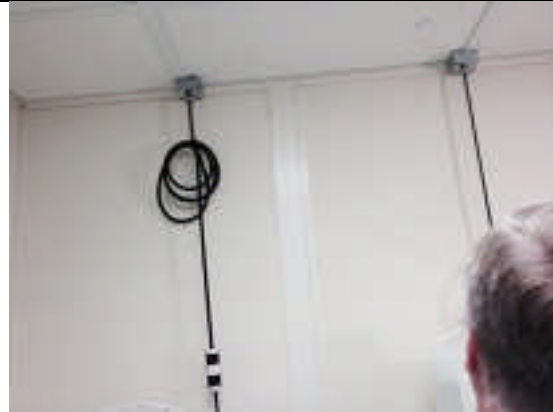
Figure 13 - IMPROPER CEILING PENETRATIONS

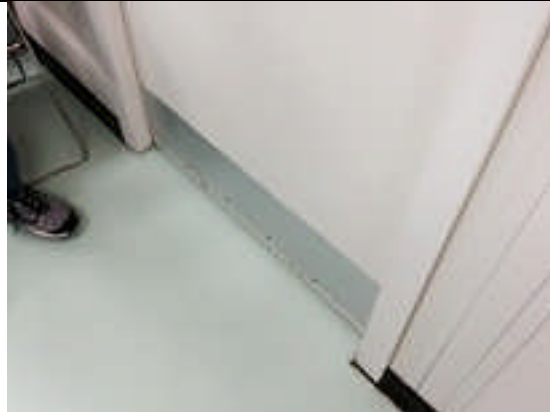
- a. The purpose of return grilles is to allow for the air to pass through the grilles to the HVAC system and then to the HEPA filters. With the grilles blocked, the passage of air is prevented, allowing potential contaminants to accumulate on the items placed in front of the grilles;
- b. Removal of the door sweeps makes it extremely difficult to accurately control room pressures and allows for contaminants to enter the room. This condition is even more likely when the HVAC is shut down;
- c. Same potential as (b) above for the cart Pass-Thrus;

Figure 14 - MISSING DOOR SWEEPS

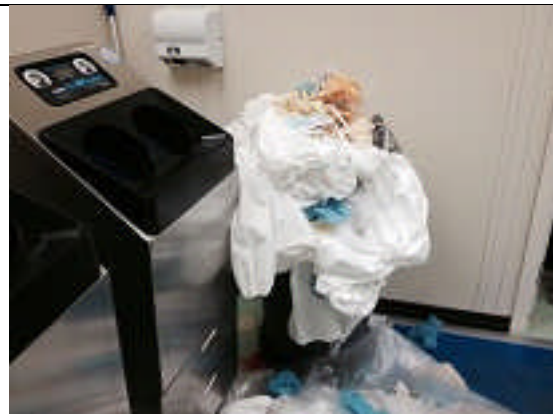
Figure 15 - OVERFLOWING GARBAGE IN THE PROCESSING AREA

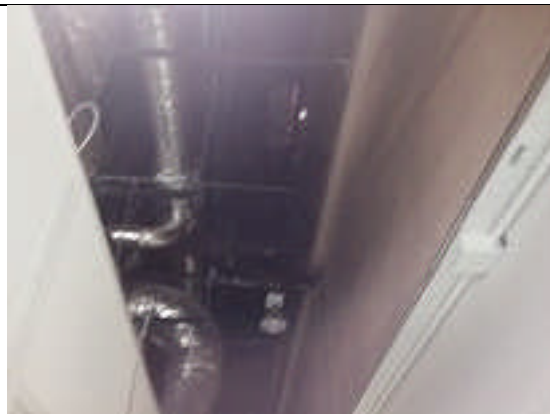
19. At no time after the roof work was completed did I observe any leaks or any evidence of leaks. However, during the July 9, 2014 site visit, obvious roof repairs were seen over and above the 2006 and 2008 cleanrooms. *See* Figure 18, p. 18. Holes in the exterior ceiling permitted daylight to shine into the Facility. *See e.g.* Figure 16, p. 18.

Figure 16 - HOLE IN EXTERIOR ROOF WHERE DAYLIGHT SHOWS THROUGH

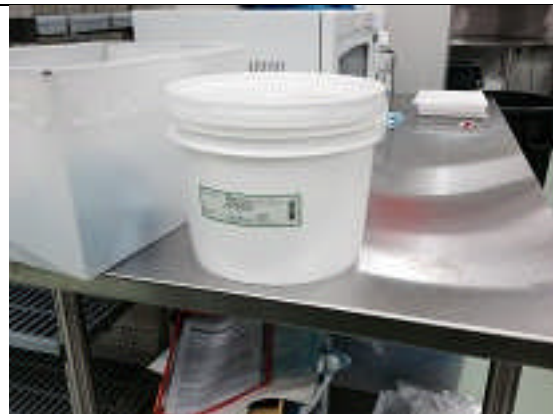
14. During the inspection on July 9, 2014, I observed a one kilogram container of MPA on a counter in the main room of the 2006 Cleanroom. *See e.g.* Figure 17, p.18. I observed MPA nowhere else in the NECC Facility during that visit. This would suggest that the MPA was produced in the 2006 cleanroom. However, Liberty has no direct knowledge of compound(s) manufactured by NECC within the three cleanrooms.

Figure 17 - CONTAINER OF MPA FOUND IN THE 2006 CLEANROOM

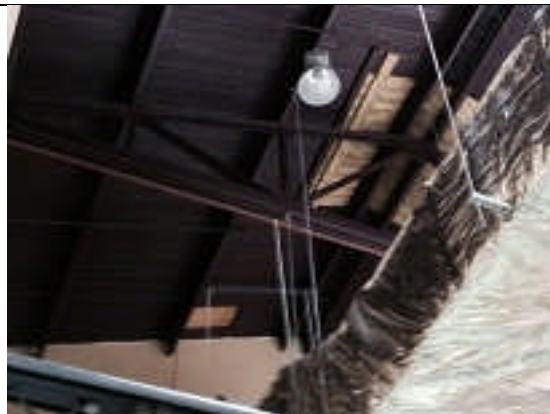
Figure 18 - EVIDENCE OF EXTERIOR ROOF REPAIRS OVER THE CLEANROOM
